**BLM Cedar City Field Office
Site Inspection Report**

May 29, 2009

File: UTU-67116
Hecla Mining Company
Escalante Mine Tailings Impoundment

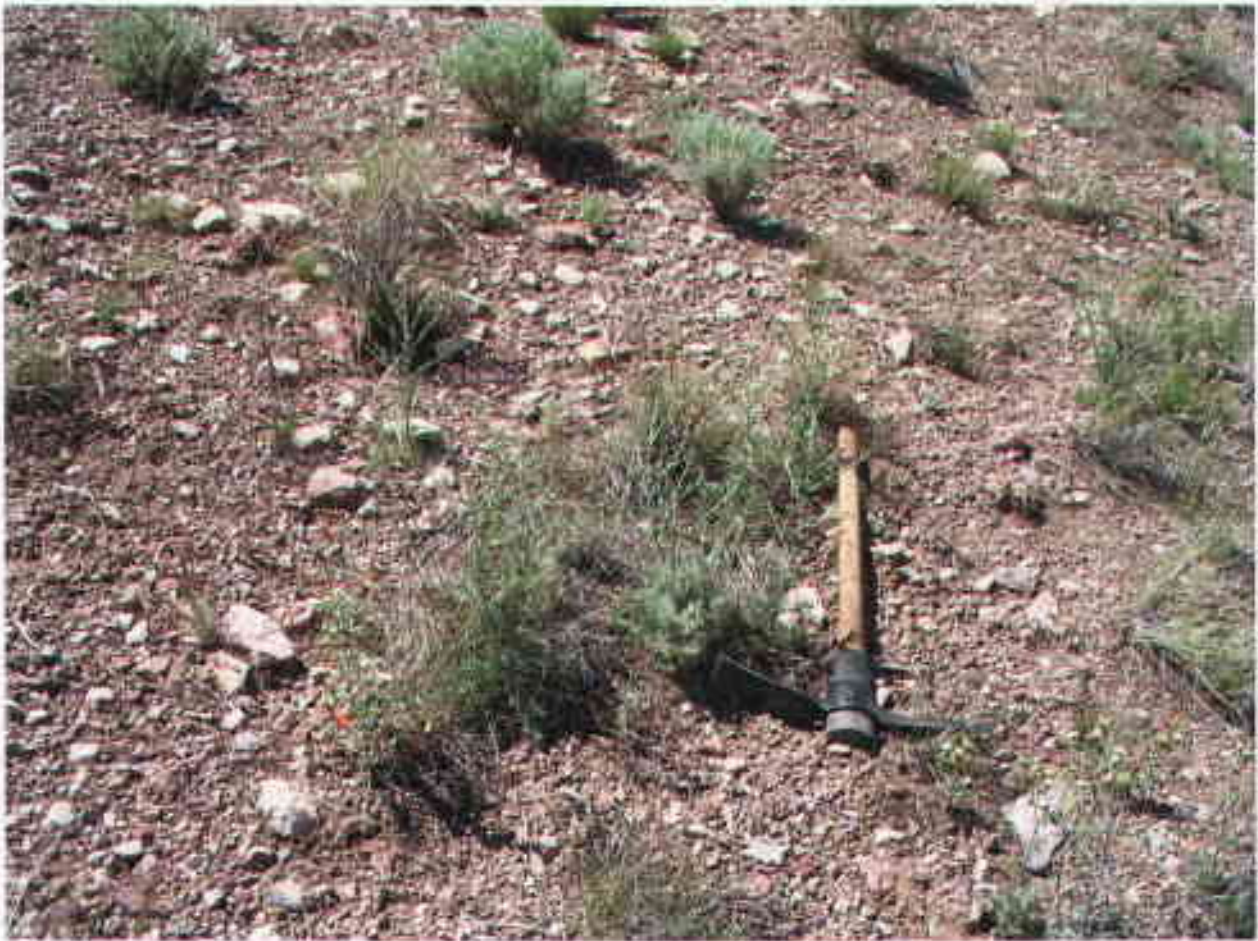
UTU-67116: Escalante Mine Tailings Impoundment
May 28, 2009

Inspection Findings: I parked the vehicle at the east gate and walked to the southern edge of the impoundment, where the bulk of the knapweed had been historically found. I searched the diversion ditch area and adjacent slopes all the way to west gate (which was still wired close). To my disappointment, I found ~ 50 plants, virtually all of which were in clusters of several plants on the north facing slope adjacent to the diversion ditch. All of the plants were in the juvenile stage and I destroyed them by uprooting. Hecla employees/ contractors must have visited the site within the last week or so as evidenced by fresh footprints in the ditch bottom and drooping of some of the knapweed plants due to being sprayed with herbicide. Most of the plants I uprooted showed no signs of having been sprayed and must have been missed by the sprayers. The presence of the plants evidences that the site can't be released yet again.

Cluster of juvenile knapweed plants on slope adjacent to diversion ditch in southeast corner of impoundment.

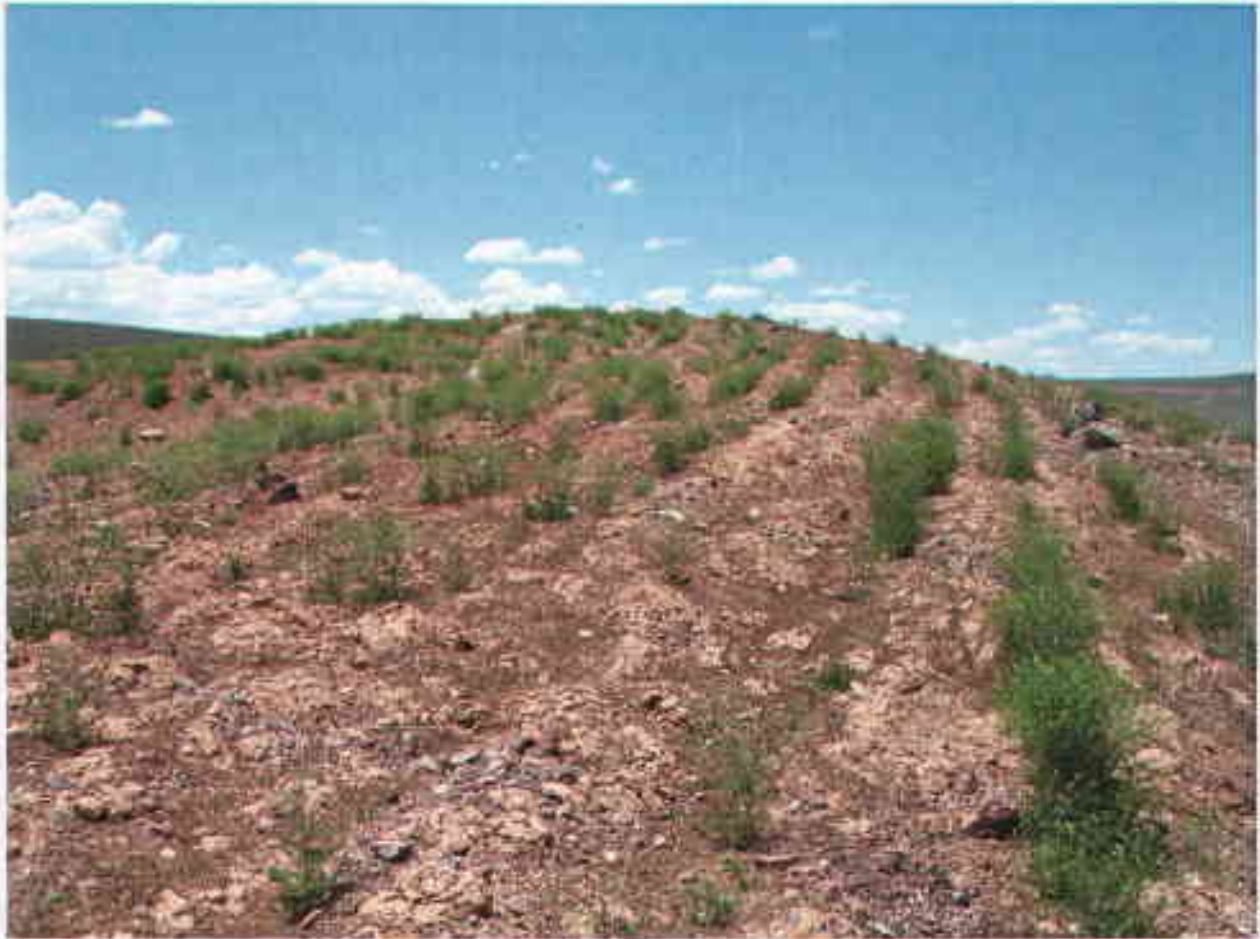
**UTU-67116: Escalante Mine Tailings Impoundment
May 28, 2009**

The vegetative cover on the reclaimed low-grade stockpile (on private land near the mill) is little changed from last year; the predominate species present are mustard, hoarhound, cheatgrass, Russian thistle. Some wheatgrass was present by estimated to be < 1% of the vegetative cover.

**View, looking westerly, along the crest of the reclaimed low-grade stockpile area (private land).
Vegetation visible is mustard.**
